Contaminant Screening Study Libby Asbestos Site, Operable Unit 4 Libby, Montana

**Final Summary Report for the
Cabinet View Country Club Investigation**

April 2005

Final Summary Report
For the Cabinet View Country Club Investigation,
Contaminant Screening Study,
Libby Asbestos Site, Operable Unit 4

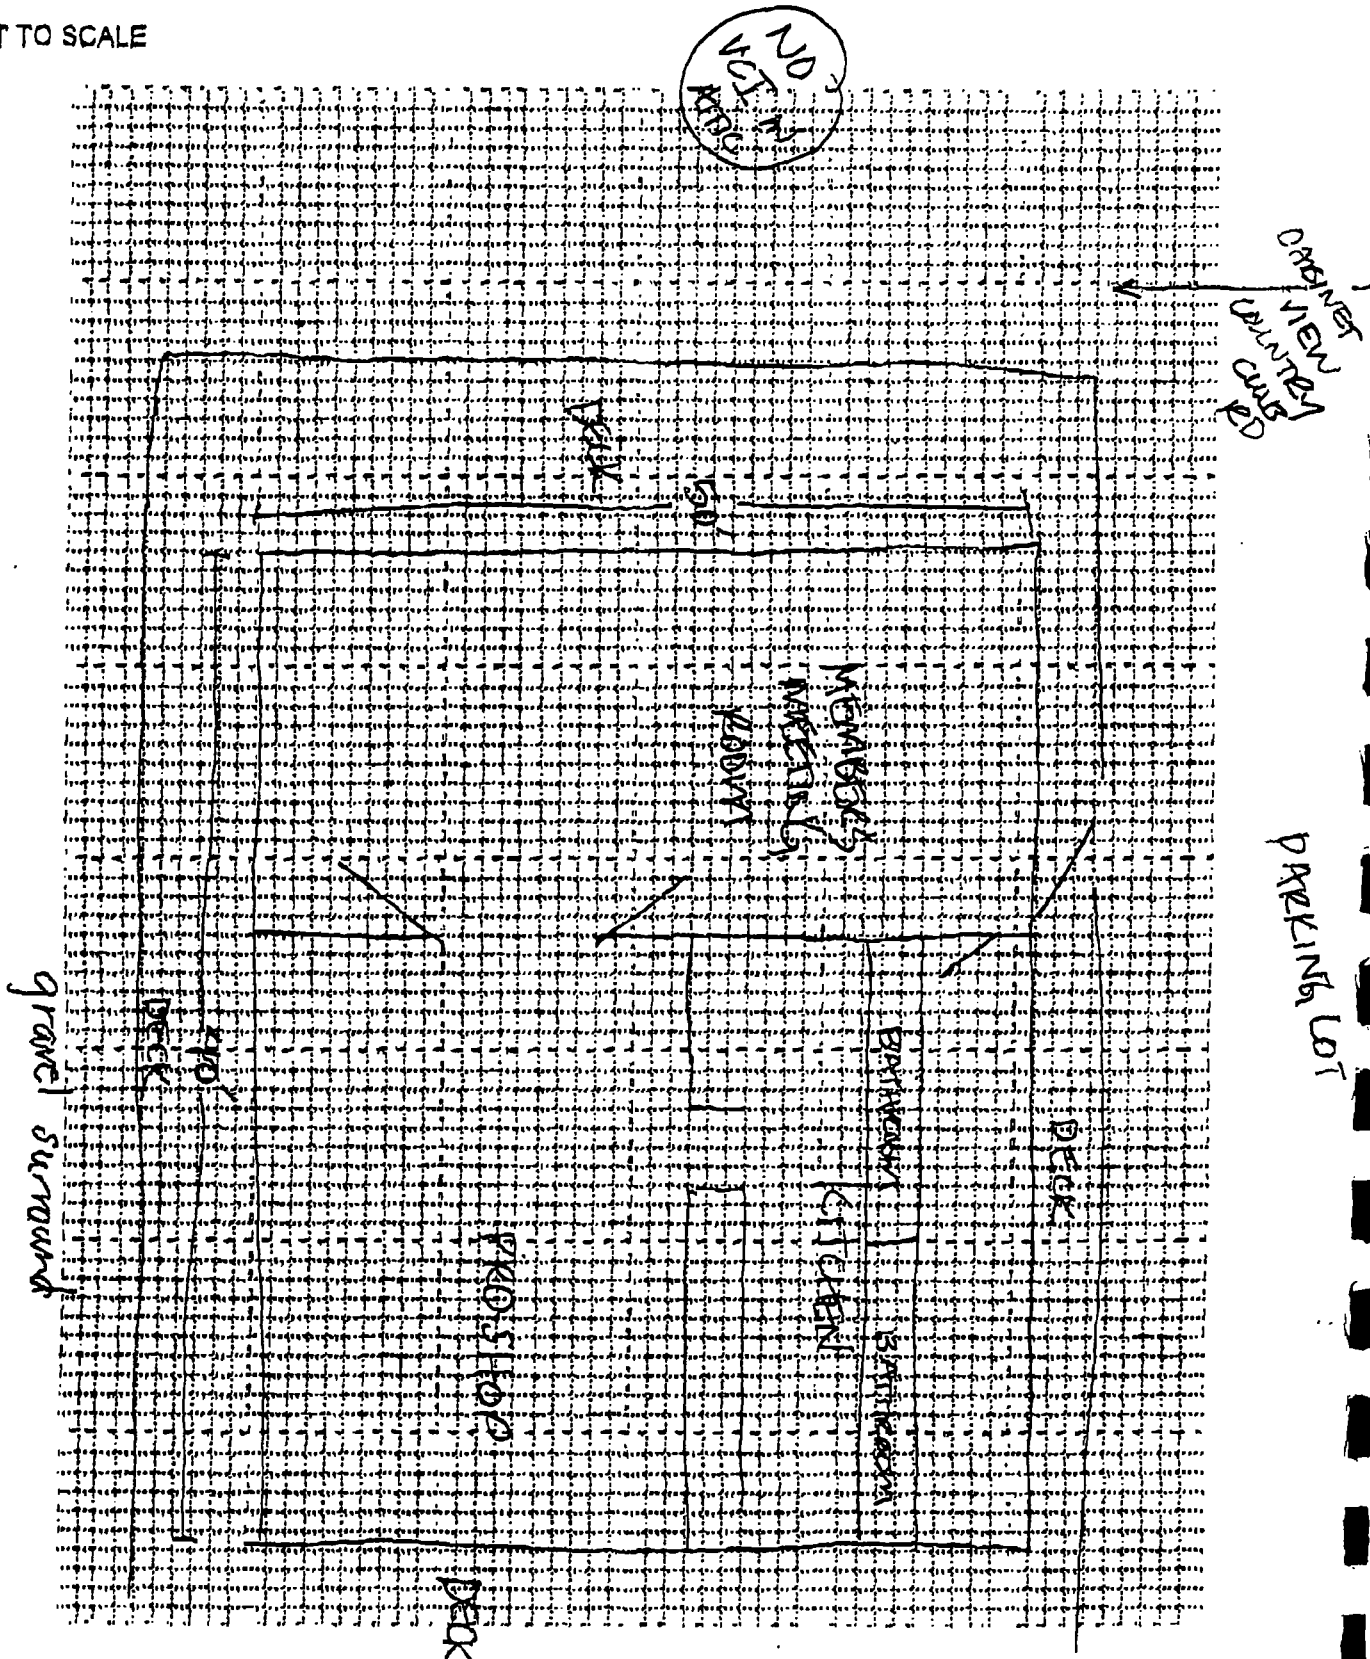
NOT TO SCALE

ADDITIONAL INFORMATION (Note any partial access or sample collection issues) <u>VERMICULITE OBSERVED</u> <u>ONLY AT DEPTH, THERE WAS A FEW FLAKES OBSERVED ON THE SURFACE</u> <u>OF HOUSE 3 @ E SANDPIT ON E SIDE.</u>

Identify important features (i.e. drainage, trees, gardens, structures, flowerbeds, utility poles, known underground utilities, suspected Libby amphibole source areas, sample locations, etc). Include north arrow.
